# Manhole Inspection Summary

Manhole # S07AA2027MH

Insp Date: **9/18/06 3:10 PM**

**Location** Address: **5859 WESTERN RUN DR**

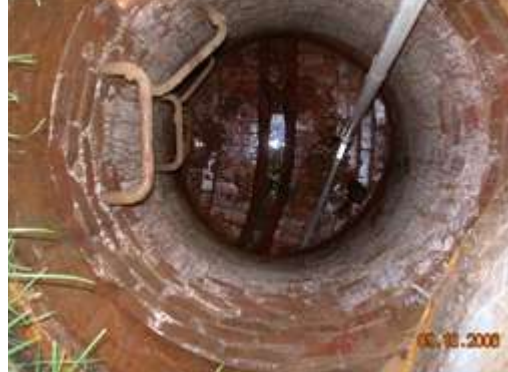
Top View

Frame leaks. Adjustment infiltration.  
Evidence of surcharge - Bench debris.  
Channel debris.

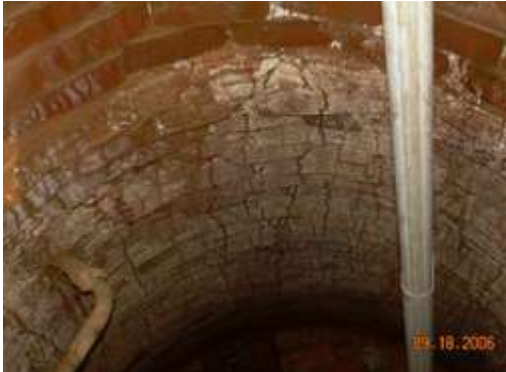
Defect

Adjustment and Corbel infiltration.

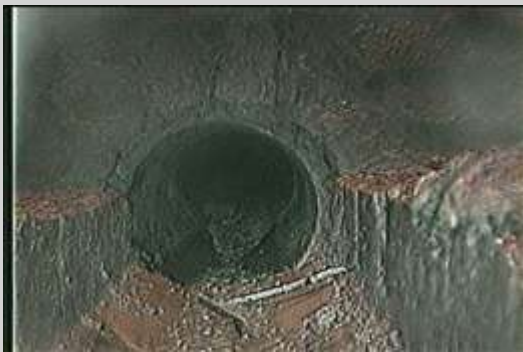
### 8 in. Circular Gravity Sewer Pipe Out @ 12 O'Clock

Deposits: ☐ None ☒ **Mud** ☐ Sludge ☒ **Debris** ☐ Grease

Infiltration: **Evidence** Pipe Seal Cond: **Cracked**

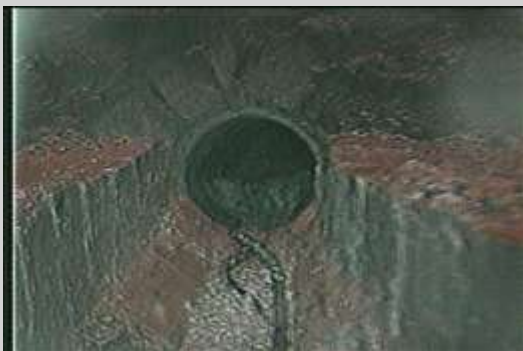
### 6 in. Circular Gravity Sewer Pipe In @ 7 O'Clock

Barrel deterioration and infiltration.

Infiltration: **Evidence** Pipe Seal Cond: **Cracked**
